Late Charge problems in the K5 area

Bernard Geiss
TEP Nederland,
5th June 2008
TNO/EBN Workshop Utrecht

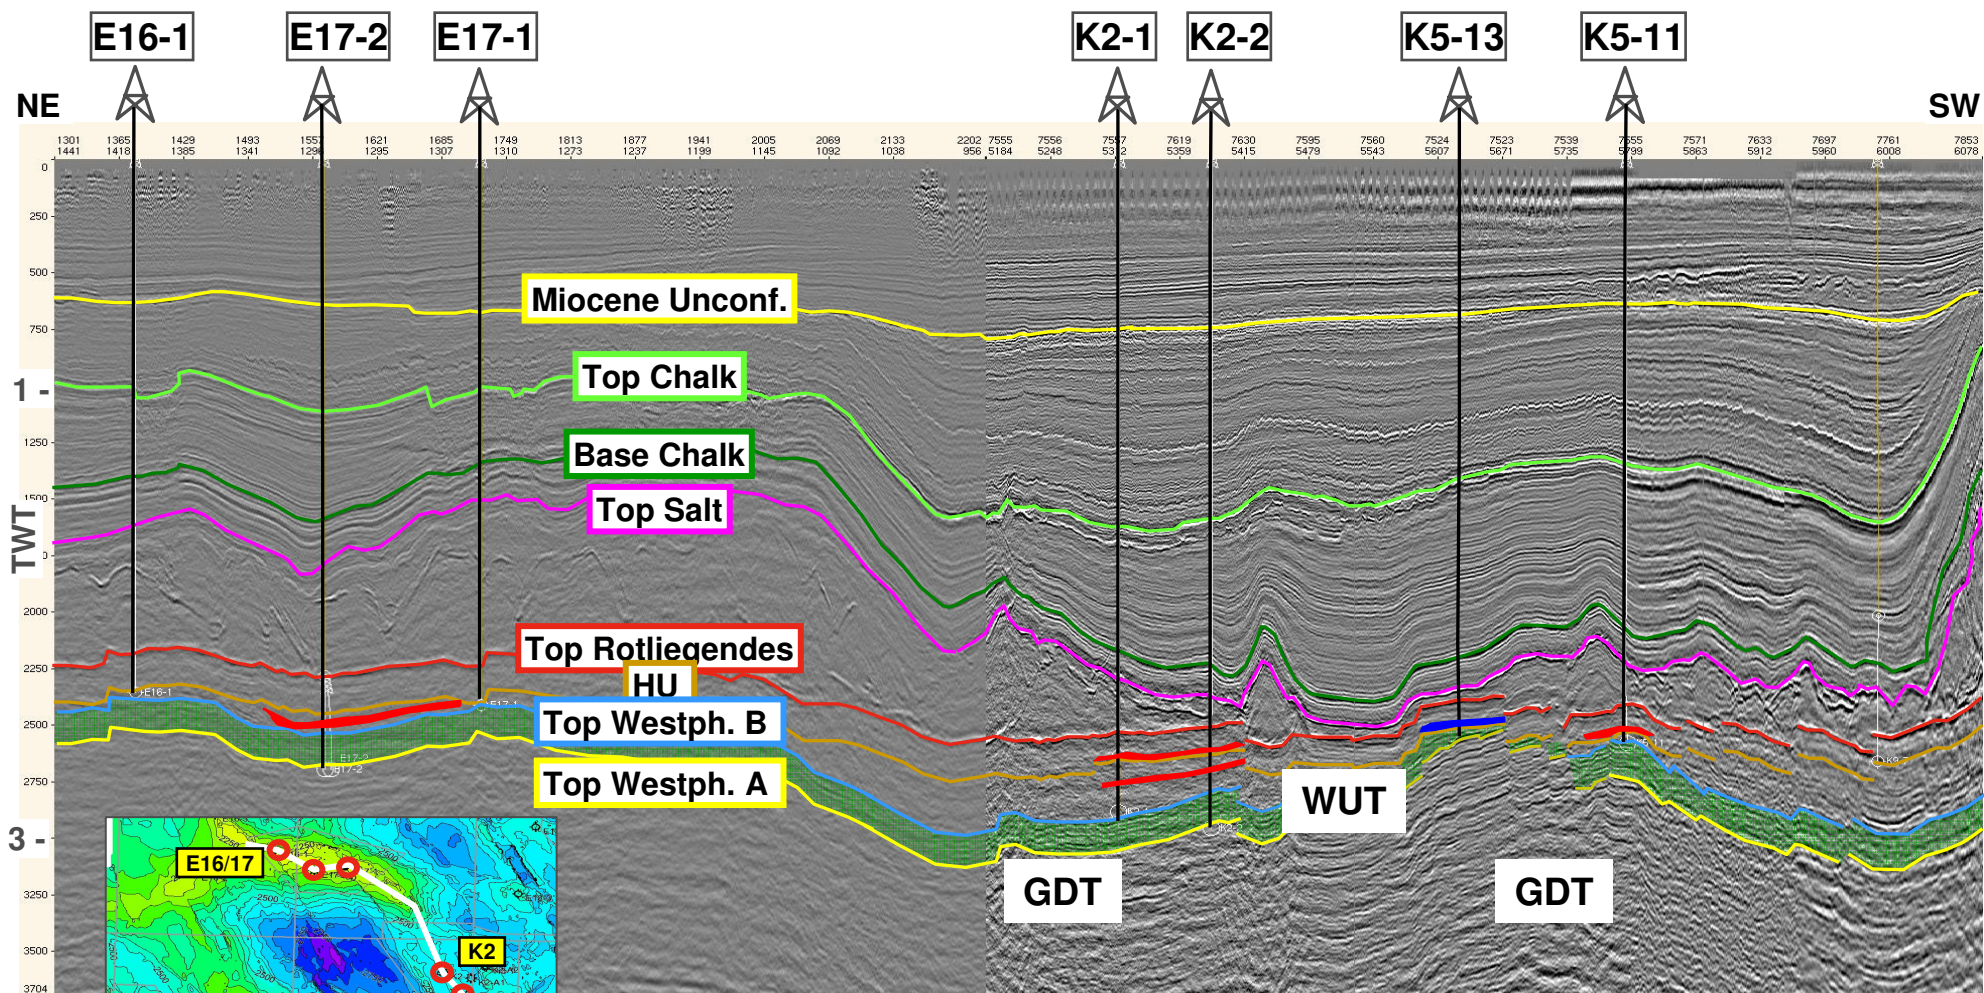
Regional seismic line

Westphalian B Coal Measures

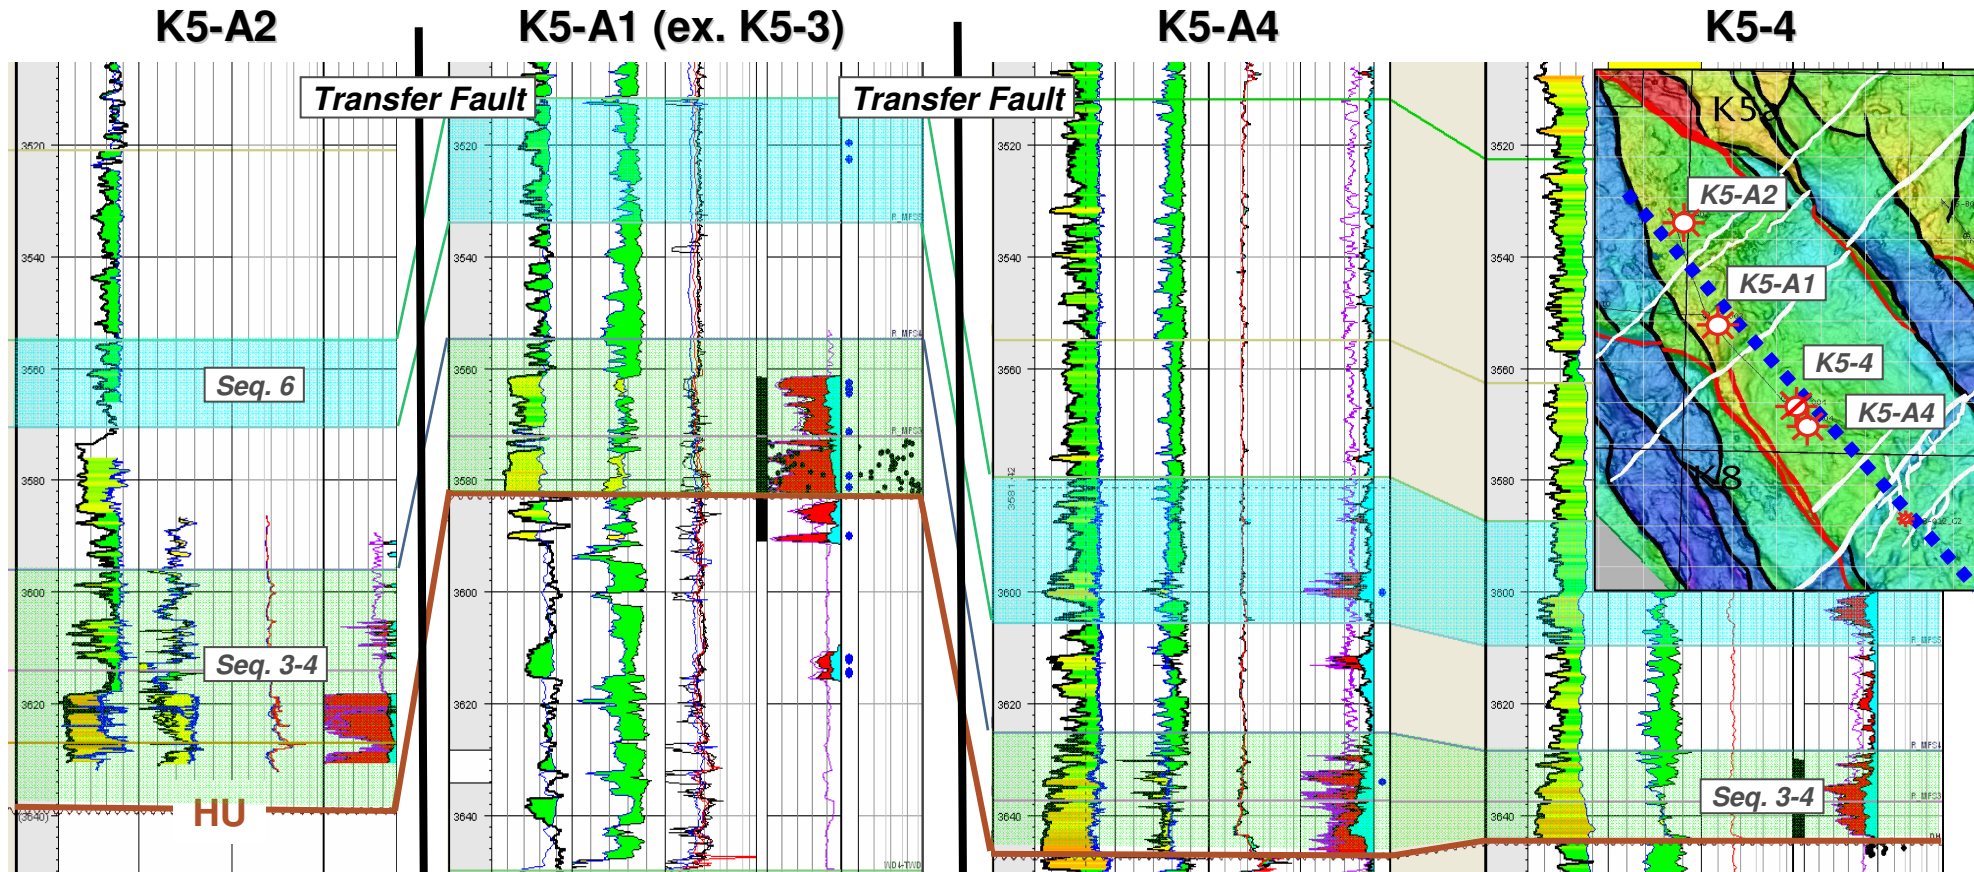
K5A Pressure History on Well correlation

BHP Lower Slochteren Reservoir Sequences 3-4

1988	409 bar	409 bar	Not yet drilled	409 bar
1994	Production start-up K5-A1 & A2		Not yet drilled	409 bar
1999	236 bar	198 bar	401 bar	
2006	126 bar	96 bar	221 bar
